RESEARCH OF THE UNACCEPTABLE DEFECTS CAUSES IN THE MANUFACTURE OF REINFORCING ROPE

This article discusses the formation of defects in the production of reinforcing rope with a diameter of 12.0 mm from steel grade 80 produced by Kaz-Metis LLP.

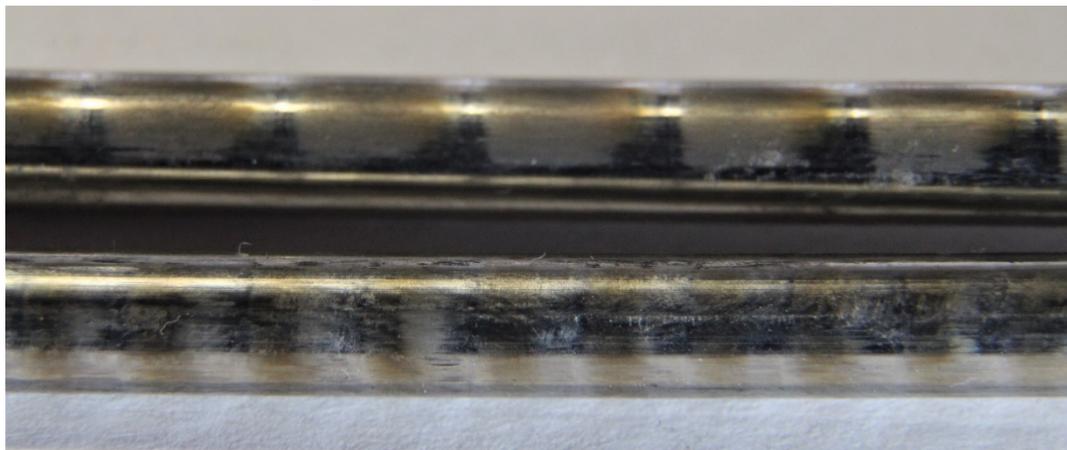
We prepare samples for visual inspection, and for this, we remove drawing lubricants from the surface. When examining the surface of the samples, they show a difference in tone (see Fig. 2), which extends approximately to a distance of 10-15 cm from the breaking point on each of the samples.

Figure 2: Appearance of the defect "heterogeneity"

For an extended deep analysis of the defect, the Altami MET 1C digital microscope was used. The defect looks like alternating light and dark stripes on the surface of the wire. The defect is generally about half the length of the wire in the sector. There are small bumps in the light areas and depressions in the dark areas.

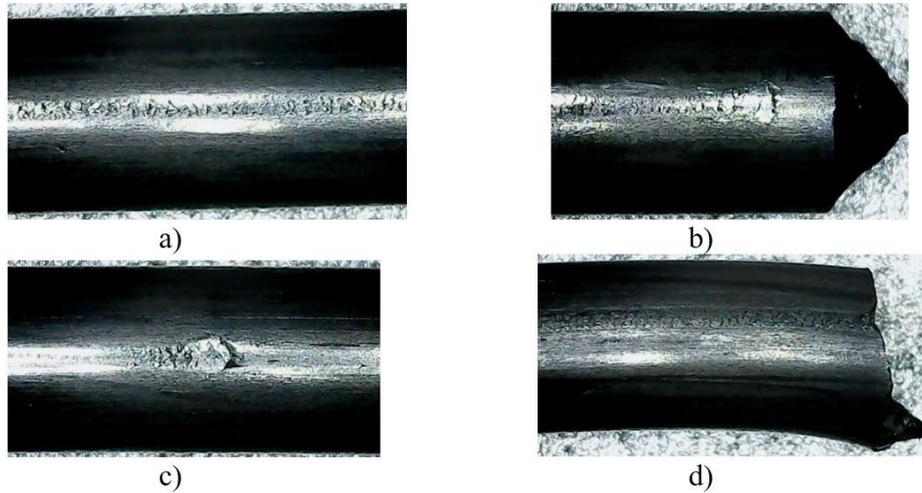
During the analysis, we identify two parallel scratches and "small flaws" on one side, which extend over the entire length of both samples. In addition, in the place of the breakage on the opposite side, there are also small flaws up to 5 mm long (see Fig. 3).

Figure 3: Samples for the study: a - The general nature of the flaws on the samples; b - The view of the flaws at the place of the break on one of the samples; c - A flaw 75 mm from the place of the break on the sample; d- Flaws on the response sample

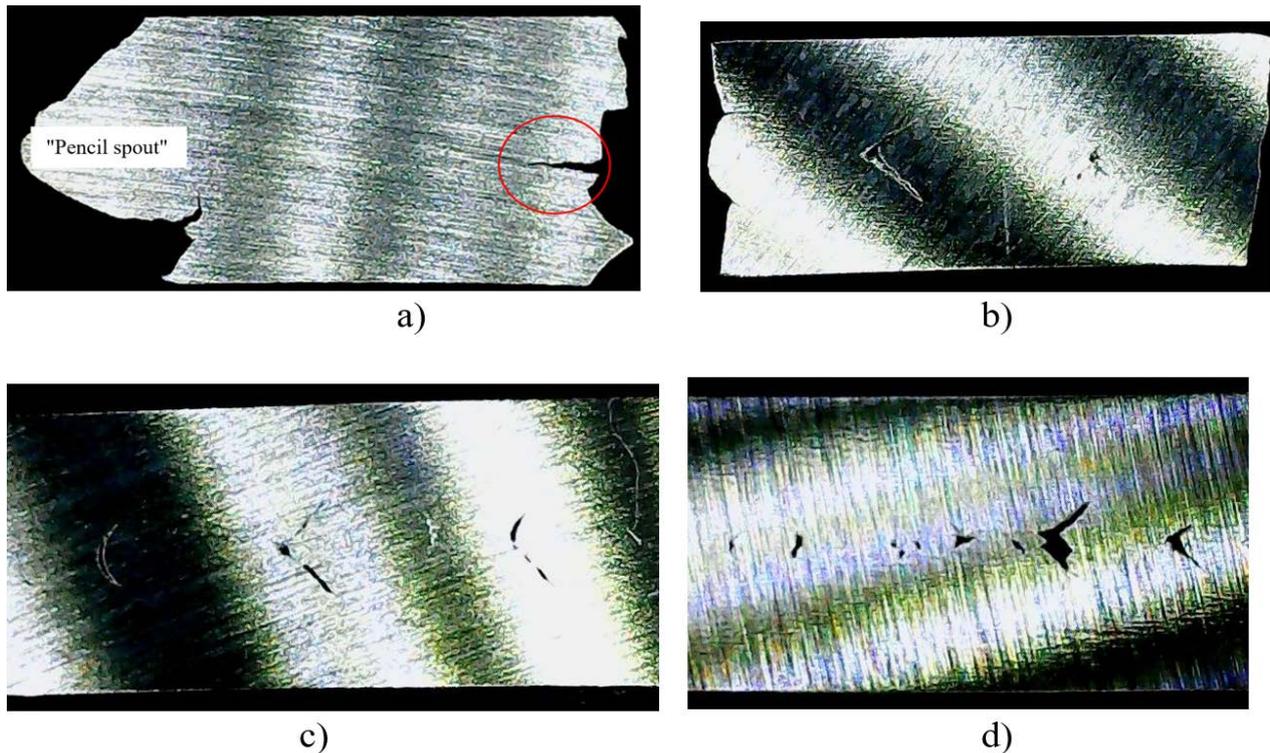
In the process of preparing samples for microstructural analysis, tears in the form of "crow's feet" were found in the metal structure. Figure 4 shows these tears on the untreated surface.

Figure 4: a - "Pencil spout" (red ovals are highlighted in cracks in the metal); b - A view of "crow's feet" at a distance of 75 mm from the breakage point (from the spout of the "pencil"); c - A view of "crow's feet" from the opposite end of the sample from the breakage point (sample with the spout of the "pencil"); d- A view of "crow's feet" and cavities from the opposite end of the second sample from the breakage point

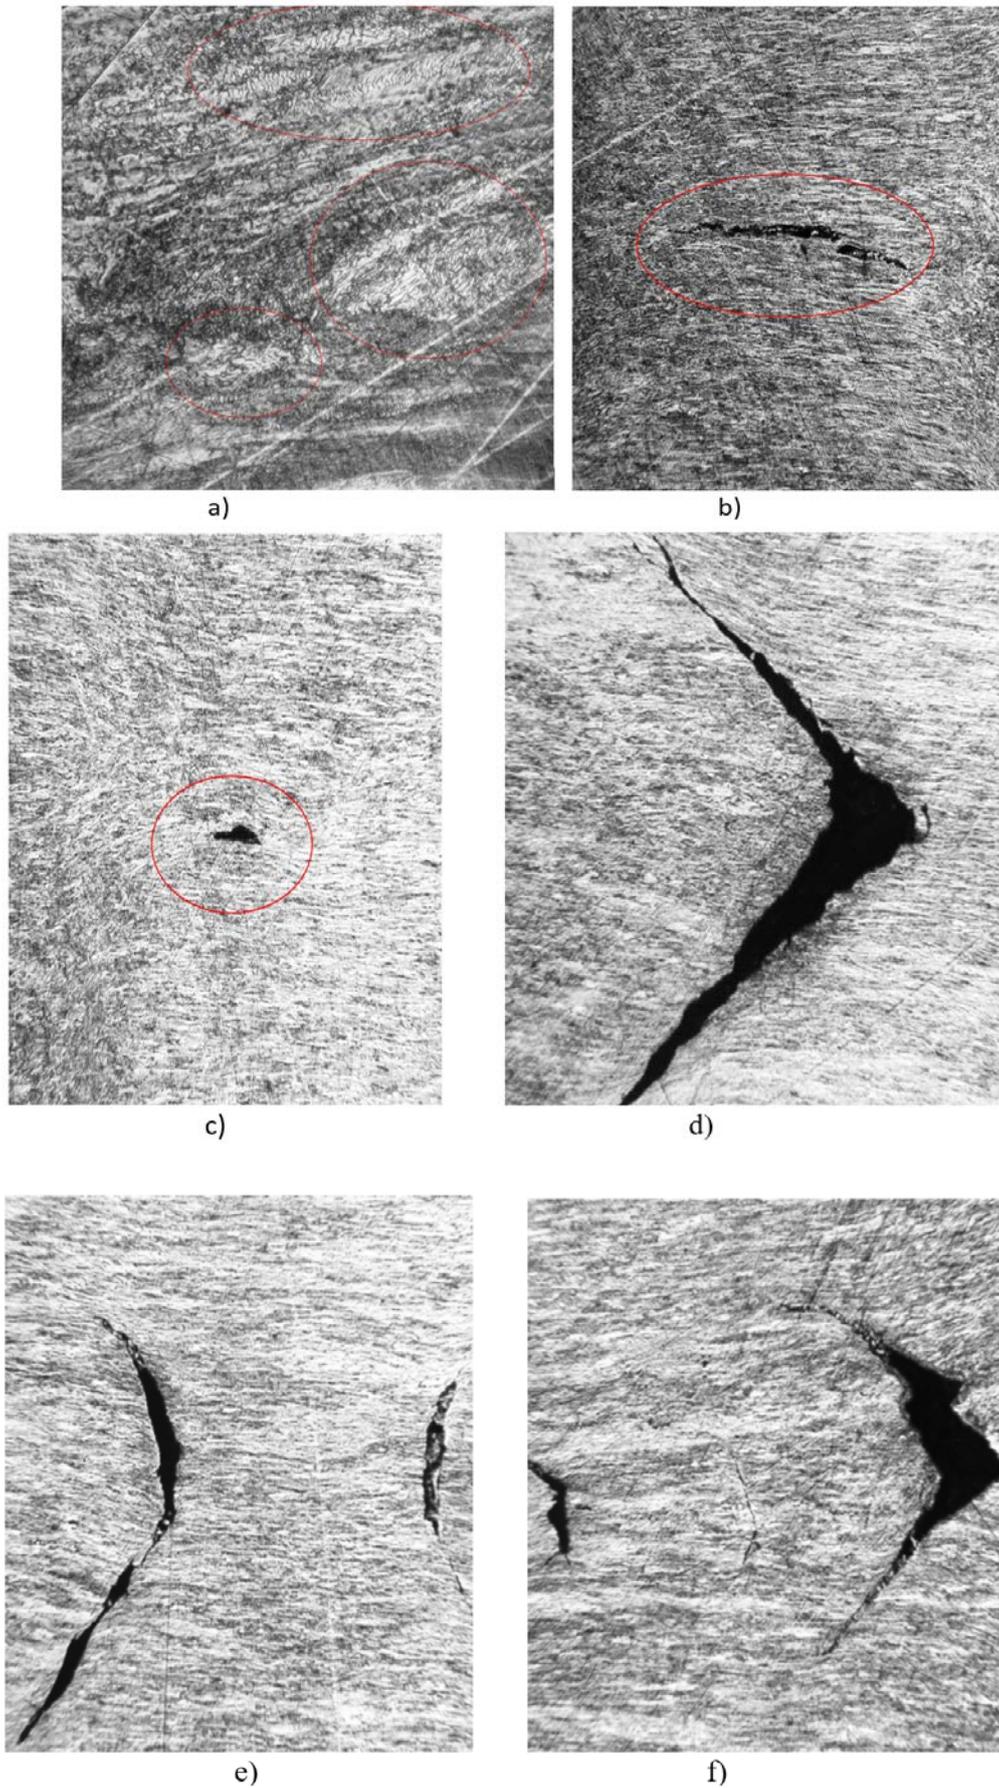
Figure 5: Microstructural analysis with a 50-fold increase

Microstructural analysis showed that when drawing the wire section where the tears occurred, there is a sufficiently large grain of perlite (see Fig.5).

a - the microstructure of steel on a wire (red ovals highlight areas with large-lamellar pearlite); b - the microstructure of steel in the area of the formed inner cavities; c - a longitudinal tear near the «pencil» nose; d - longitudinal strain within 5 mm from the tip of the "pencil"; e - one of the characteristic tears of the "crow's feet"; f - "crow's feet" from the opposite end of the sample with a "pencil" tip

Microstructural analysis on an Altami MET 1C microscope showed that during the production of wires where tears occurred, there is a rather large pearlite grain (see Fig. 5, a), which provoked the appearance of tears in the thickness of the metal.

The reason for the formation of tears was a violation of the heat treatment technology in the wire patenting line, namely hardening, as a result, large-lamellar perlite formed in the steel structure, and this, in turn, led to the destruction of the wire.
