SLOPE STABILITY ANALYSIS DUE TO INFRASTRUCTURE DEVELOPMENT OF RATU BOKO SITE YOGYAKARTA INDONESIA UNDER EARTHQUAKES LOADING

The Ratu Boko site is a cultural heritage that has a high historical value and located about 30 kilometers to the east of Yogyakarta. Instability of the slope occurred due to the Yogyakarta earthquake in 2006, and it was indicated by the occurrence of cracks in the resto building that built on the top of the hill. The first reinforcement of the columns and foundations of the outside building was used a reinforced concrete that built-in 2012. The similar reinforcement on the inside building column and foundation was finished in 2017. In this research the displacement of the reinforced foundation, and slope stability generally both in safety factor and deformation were evaluated. The deformation and displacement analysis of the foundation were solved using Finite Element Analysis. On the other hand, for the safety factor of the slope, Limit Equilibrium Method was used. The simulation is divided into several stages, starting from the existing condition, after the first and second reinforcement, and also after increasing load due to development plan. Based on the

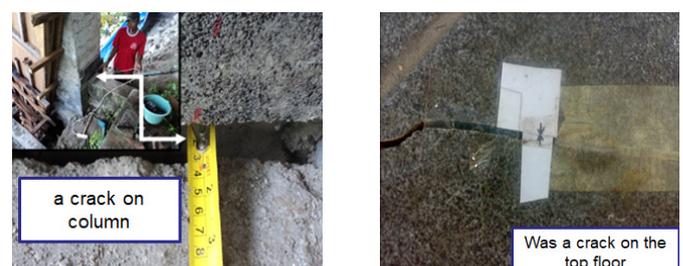
Due to the Yogyakarta Earthquake in 2006 with 5,9 Mw, cracks were found on the beam and column joint, partial retaining walls, and open pipe connections, especially on the continuous connections with the slopes in Plaza Andrawina building as illustrated in Fig. 1 [3]. It can be considered that the crack occurred in the building as a result of slope instability. At the moment, to reduce the displacement of the slope, varying reinforcement has been installed in Plaza Andrawina. All of the reinforced foundations were installed until the breccia rock layer in the slope.

Figure 1: Some cracks on Plaza Andrawina

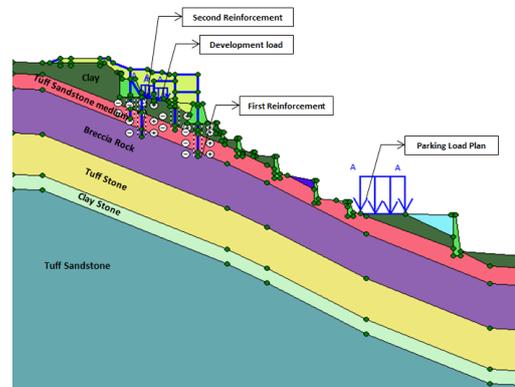
Figure 3: Cross Section of the Slope [15]

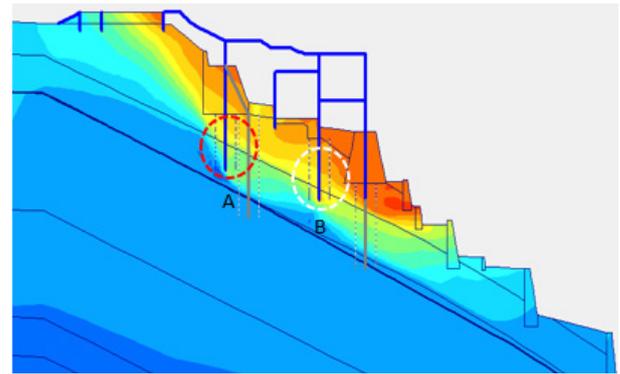
In this condition, Plaza Andrawina was simulated without reinforcement. It was found that Earthquake loads have a significant effect on horizontal deformation on the foundations at both points reviewed. The deformation values that occurred by using PGA of 0.15 g at points A and B consecutively were 58.15 and 76.52 mm. For PGA 0.25g the deformation values occurring at Points A and B were 86.32 and 108.00 mm. The results of the simulations using two different seismic loads indicate that larger PGAs result in greater deformation as well. For detail of horizontal deformation can be seen in Fig 4.

Figure 4: Deformation of Existing Condition at Point A and B (Initial Stages) [15]

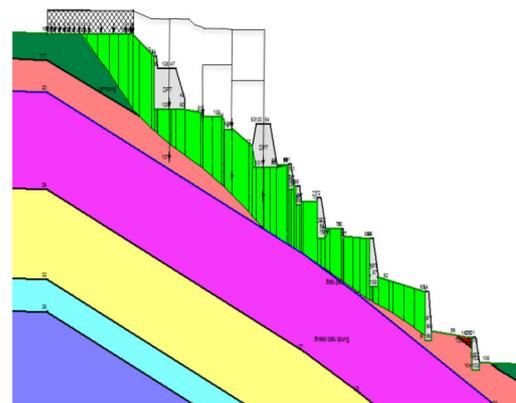
Furthermore, the analysis with slope/W performed on this existing condition is a condition where there is no reinforcement and assume that the three columns in front remain at the position (not slipping). The results of the slip surface and the safety factor of this condition can be seen in Figure 5.

The results of the analysis using dynamic loads show the safety factor of slope with PGA 0.15g in accordance Yogyakarta earthquake 2006 is 1.362. And the safety factor dramatically reduced in PGA 0.30g to the critical slope of 1.138.

Figure 5: Slip surface of existing condition without reinforcement [15]

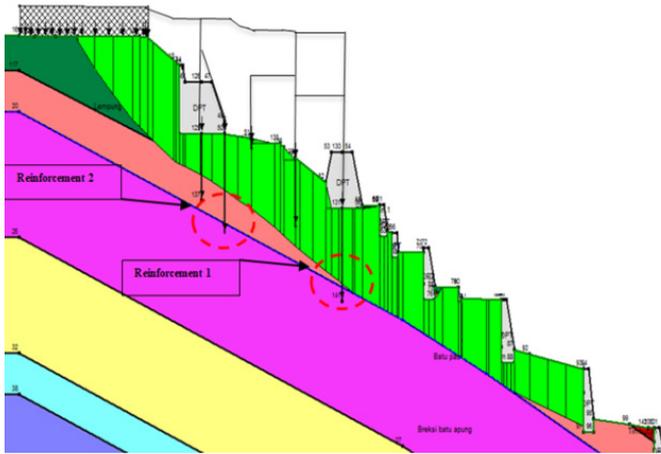
Figure 6: Slip surface after second reinforcement as illustrated with red circle [15]

This second reinforcement installed in the back column of Plaza Andrawina. The results of slip surface and safety factor analysis are presented in Fig 6.

Furthermore, the slip surface occurs only in the first and second layers of the clay layer and the tuff sandstone layer. The result of analysis shows that the second reinforcement gives a big influence on the slope stability which is increase of the slope safety factor to 1.351.

This second reinforcement is the same as the first reinforcement using reinforced concrete with the foundation end of reaching a layer of deep breccia rocks as deep as 0.5 m. The depth of this second reinforcing foundation differs from each column, with an average depth of 5-7 m. The simulation using the second reinforcement reduces the deformation value occurring at both the foundation point under review. The deformation values that occurred by using PGA of 0.15 g at points A and B were 9.44 and 8.03 mm, respectively. For PGA 0.25g the deformation values occurring at Points A and B are 16.08 and 14.95 mm, respectively.

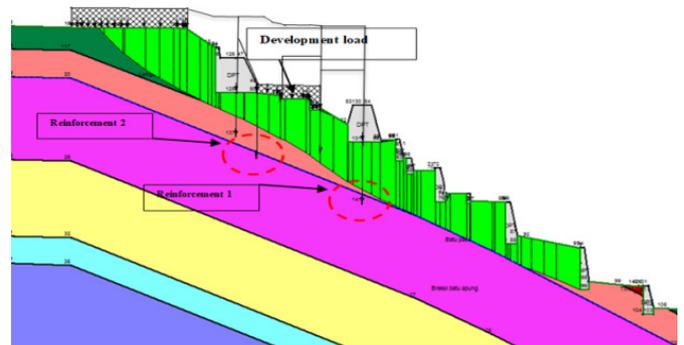
The result of the safety factor analysis shows that after the addition of development load on the second floor gives an effect on the stability of the slope that is by decreasing the slope safety factor to 1.318. The slip surface of this condition can be seen in Fig 7.

Figure 7: Slip surface after Development Load on Plaza Andrawina [15]

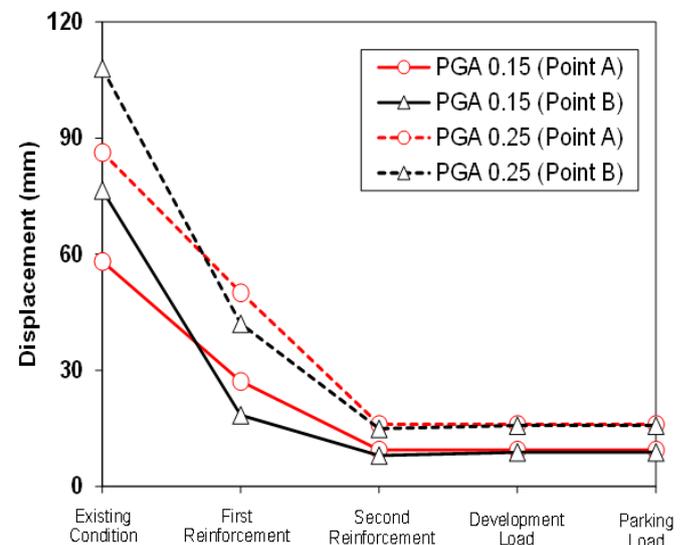
Based on the analysis that has been done on various conditions, the horizontal displacement values for the two foundation points reviewed are point A and point B. The overall detail is shown in Fig 8.

When using Yogyakarta earthquake load 2006 that is with PGA 0,15g can be seen that existing condition without reinforcement has horizontal displacement at point A and point B successively 58,15 and 76,52 mm. The horizontal displacement that occurs increases significantly when using the earthquake load with PGA 0.25g, that is at point A and point B successively 86.32 and 108.00 mm.

Furthermore, after the construction of the first reinforcement on the outer column there is a decrease in horizontal displacement at both points reviewed. The decrease in displacement value that occurs is quite significant, especially at point B which is close to the reinforcement.

Figure 8: Reduction of Horizontal Displacement

The horizontal displacement value at the foundation of point B is reduced by almost 50% using either PGA 0.15g and 0.25g. The displacement values that occurred respectively were 18.41 mm and 42.05 mm.

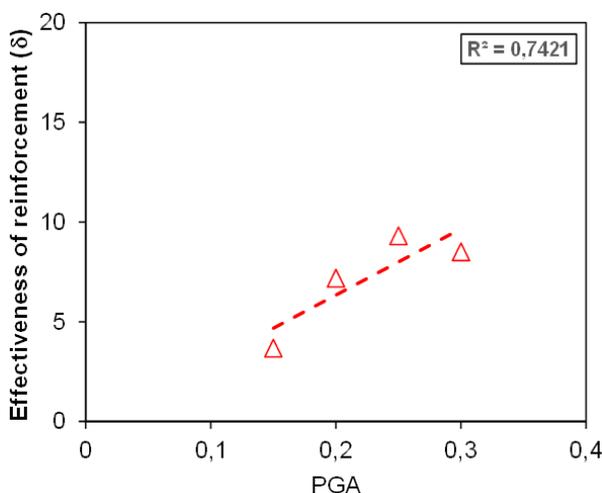
Figure 9: Effectiveness of Reinforcement

The effectiveness of first reinforcement (δ) is illustrated in Fig. 9. It can be observed that the good correlation was obtained with earthquakes load (PGA). The reinforcement significantly effective to maintain slope stability.
