EVALUATION OF ULTRASONIC PULSE VELOCITY (UPV) FOR REINFORCED CONCRETE CORROSION

Yousef Almashakbeh^{1*}, Eman F. Saleh²

This study was undertaken to evaluate the efficiency of the ultrasonic test for detecting reinforcement corrosion levels under varying conditions and to form a correlation between the ultrasonic pulse velocity (UPV) values and the flexural capacity of corroded beams. To establish this, several reinforced concrete beams were cast and subjected to an impressed current accelerated corrosion process. The severity of corrosion was then investigated using the UPV test and four-point loading test. The results showed that the UPV test values vary with the corrosion level of reinforcement in concrete beams. However, the degree of variation in UPV test values at different levels of corrosion does not permit a clear cut for the evaluation of corrosion severity, particularly at low levels of corrosion. The four-point testing of corroded beams showed that corrosion affects the flexural capacity and ductility of the beams. This effect was correlated in this study with the UPV test values. The correlation analysis showed that there exists a moderate to a high positive correlat

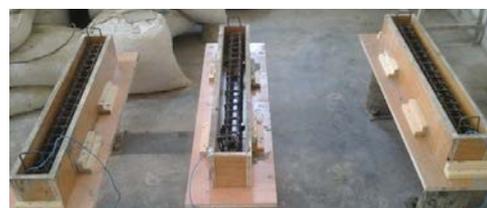
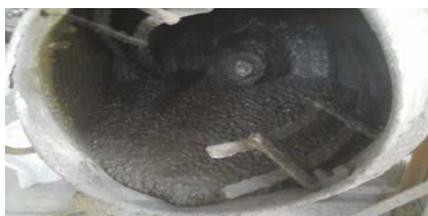
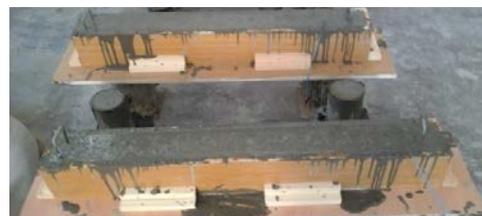
(b) Steel reinforcement cage inside the wooden mold

(c) Mixing of concrete

(d) Casted specimens

Fig. 3. Mixing, casting, and curing of beams

To cast the test specimens, internally dimensioned hardwood molds (100×150×1000 mm) were produced. Before casting the concrete, the steel reinforcement was constructed and set in cage-shaped molds. Each batch consisted of three beams and three cylinders (100×200 mm) cast in a tilting drum mixer with a batch capacity of roughly a quarter m³. The slump was found to be around 50 mm by testing (per ASTM-C143). Three layers of new concrete were poured into the wooden molds, one on top of the other, each layer vibrating on the compacting table. After 24 hours, the beam specimens were demolded and wrapped in moist burlap for 28 days to cure. Figure 3 illustrates the construction phases.

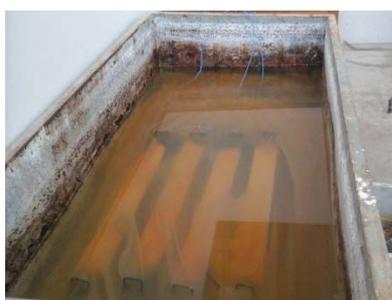
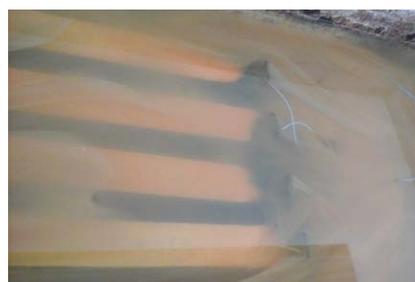
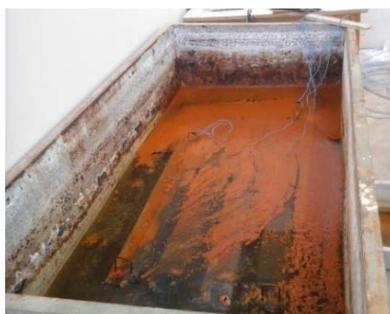
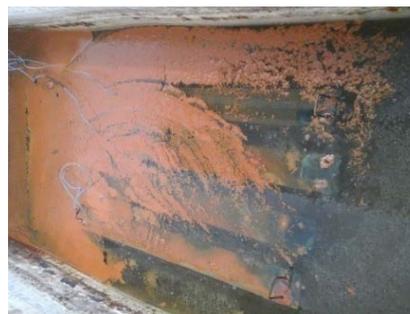
(a) General overview

(b) Connecting the anode and cathode with the device

(c) After three days

(d) After eight days

Fig. 4. Accelerated corrosion procedure

Impressed by electricity, the corrosion process on the reinforced concrete beams was accelerated using DC current. The rapid corrosion process was done by passing DC (direct current) through metallic wires placed before casting to both the longitudinal steel bars and stirrups, which function as anodes within each beam. A steel plate with dimensions of (800×300×10 mm) was used to make the cathode, which was connected to the cathode wire. A current density of 200 A/cm² was applied to the specimens. To establish an aggressive environment, samples were placed in a tank containing a 2% NaCl solution. Figure 4 illustrates the processing phases.

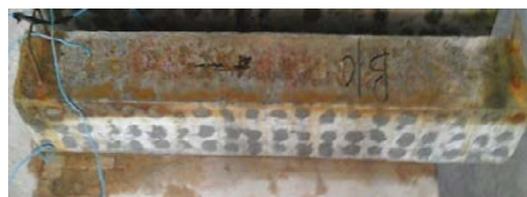
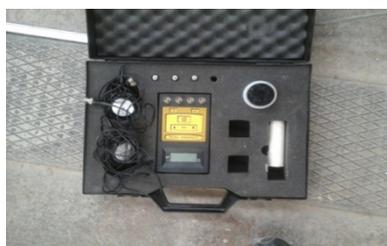
(b) After test

(c) Ultrasonic pulse velocity apparatus used

Fig. 5. UPV measuring process

Nondestructive tests are used to determine the physical properties of concrete, such as discontinuities and changes in the material composition and degree of corrosion, without damaging the samples, allowing them to be reused following the test. The UPV was performed directly on two opposite sides of the beam separated by 10 cm. On the two sides of each beam, a square cell grid of 5 cm width was drawn to assist the UPV measurements. The UPV determines the speed at which the ultrasonic pulse travels between two opposing sides of the reinforced concrete beam. Three successive UPV measurements were taken (before corrosion, after 3 and 8 days of corrosion). Each beam was subjected to 60 UPV measurements in total for each case. Figure 5 illustrates the UPV measuring process.

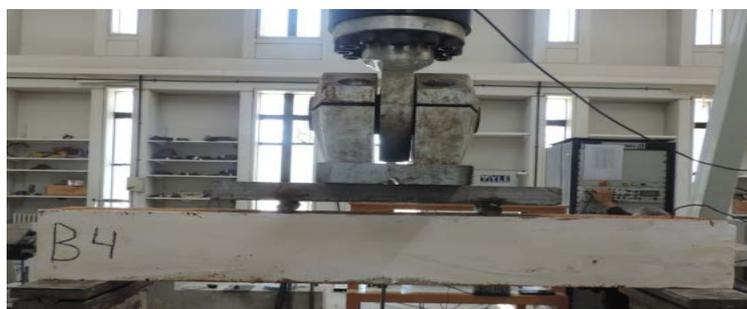
Fig. 6. Four-point flexural test setup

Flexural testing was performed on the beams with four-point loads across a 0.9 m span using a basic support setup. A 300 mm space remained between the two loading locations. The beam was supported by a particular type of hardened steel support to ensure that no deformation occurred that might affect the test results. All beams were loaded with two-point loads at a loading rate of 0.3 kN/sec using 400 kN hydraulic testing equipment. On one end, the supports operate as a hinge, while on the other, they function as a roller. A linear variable displacement transducer (LVDT) was used to determine the vertical deflection at the mid-span. Load-deflection curves were developed using load cell and LVDT data. The test setup is depicted in Fig. 6.
