STRENGTHENING AND OVERBUILDING OF CAR SERVICE „AUTOMAKEDONIJA“ IN SKOPJE, MACEDONIA

Keywords: strengthening, mechanical properties, reinforced concrete structure, steel structure

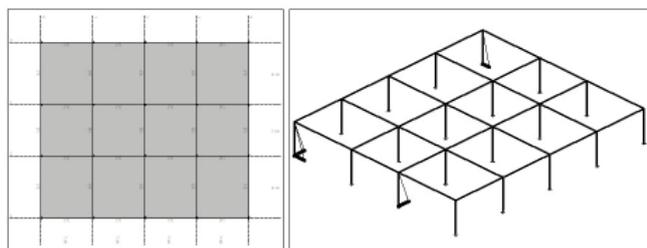
The orthogonal frames of the old building structure consist of reinforced concrete columns and beams. The dimensions of all columns are 40/40cm, while the beams are with rectangular cross sections of two different sizes: the internal beams in x-direction are 50/45cm, while all the others are with dimensions of 40/45cm, see Figure 1.

Figure 1. a) Layout of the building; b) 3D model of the building

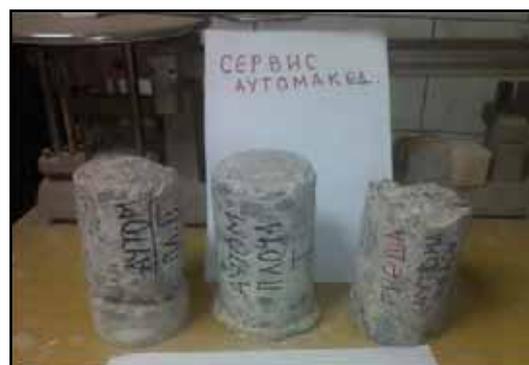
These results were not sufficient; therefore kerns had been taken out as another method for confirmation of the concrete class for all structural elements. One cylindrical sample was taken from the slab and two from the beams, see Figure 2.

Figure 2. Three sample cylinders taken from the slab and the beams

label	ϕ	h [mm]	V	G [gr]	γ [kN/m ³]	F_c [MPa]
slab I	94	103.4	717.2	1746.4	24.35	31.1
slab II	94	93.6	649.2	1528.9	23.55	27.6
G-1 beam	94	93.1	645.7	1527.6	23.66	23.2

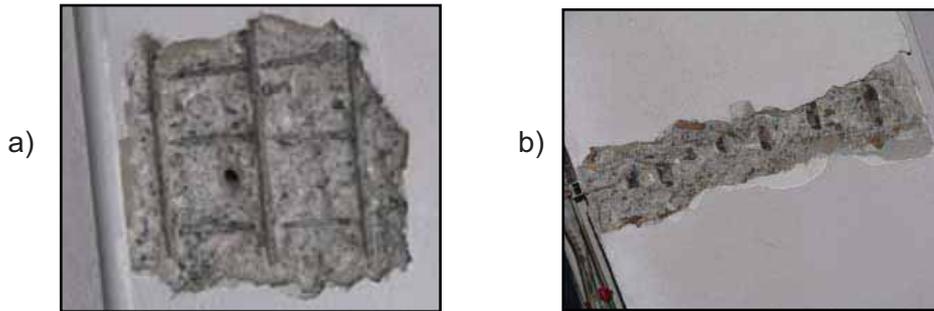
With opening of the structural elements, i.e. removing the mortar layer and the protective concrete layer, the reinforcement in the elements was determined, see Fig. 3. All of them have been reinforced with smooth reinforcement GA 240/360, typical for the period of the building construction.

Figure 3. Reinforcement in the structural elements: a) slab, b) beam

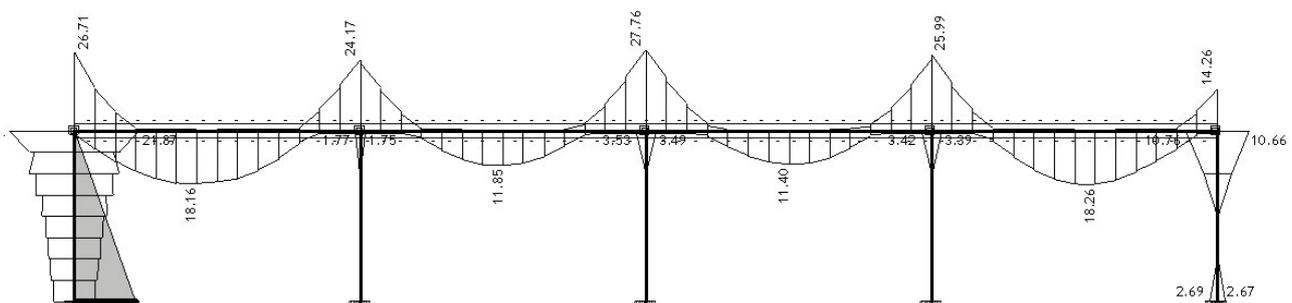
Figure 4. Maximal bending moments in one of the frames in y-direction

The integral calculation of the existing strengthened and overbuilt structure is performed with three dimensional model, using the sophisticated software package TOWER6. The analysis of the loads comprises: permanent loads, imposed loads, loads of the overbuilt steel structure and seismic loads. The maximal period obtained due to seismic action is 0.338 sec in x-direction, and 0.3079 sec in y-direction. The appropriate maximal displacements at a level of the existing structure are 4.94 mm and 4.1. mm. The control of the bearing capacity of the structural elements has been performed using the characteristic loads envelope, according to the Rulebook for concrete and reinforced concrete – PBAB 87. Detailed representations of the load cases, geometry of the structure, bending moments envelopes and necessary reinforcement were given in the Main design of the overbuilding, see [1]. Typical examples are presented in the Figures 4 and 5.

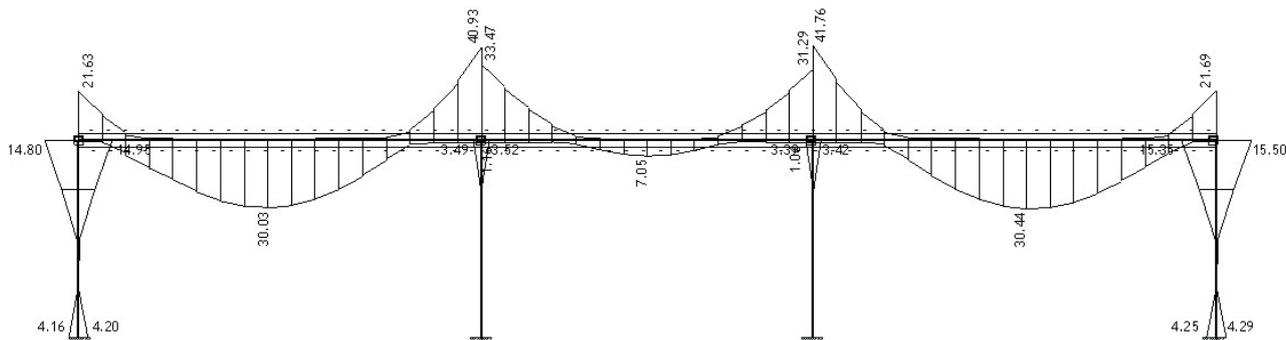
Figure 5. Maximal bending moments in one of the frames in x-direction

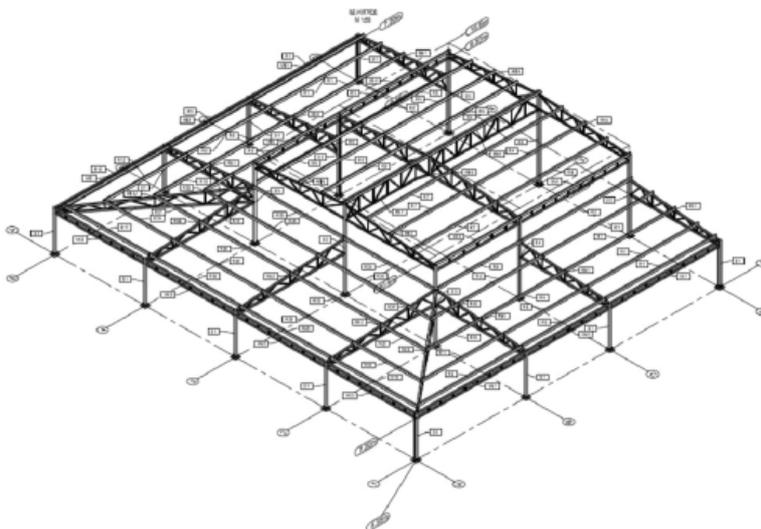
reinforced concrete columns. The connection of the steel columns with the existing structure is performed using 8 anchors of $\varnothing 16$ for each column, sealed in the perforated holes ($\varnothing 25$) in the concrete. The part of the overbuilding between the rows B and D and the lines 2 and 4 is elevated with a ridge in the middle (line 3). The edge parts are lower, with drainage towards the building sides, see Fig. 6.

Figure 6. Three-dimensional model of the steel structure for overbuilding

The overbuilding is designed of light steel structure with tubular square and rectangular cross sectioned profiles. Before the construction of the steel structure, the layer of low quality concrete with single slope and the hydro-insulation with average thickness of 10cm should be removed from the reinforced concrete slab, which represents a load of 2.4 kN/m². The columns are designed as SHS150.6 placed over the existing

Span structure consists of truss girders framed in the columns. The trusses are placed in the rows B, C and D with span of 7m each, except the truss between the lines 2 and 4 which span is 14m, i.e. there is a lack of a column at position C-3. Sliding trusses are designed between the columns A-1 and B-2, as well as between the A-5 and B-4.

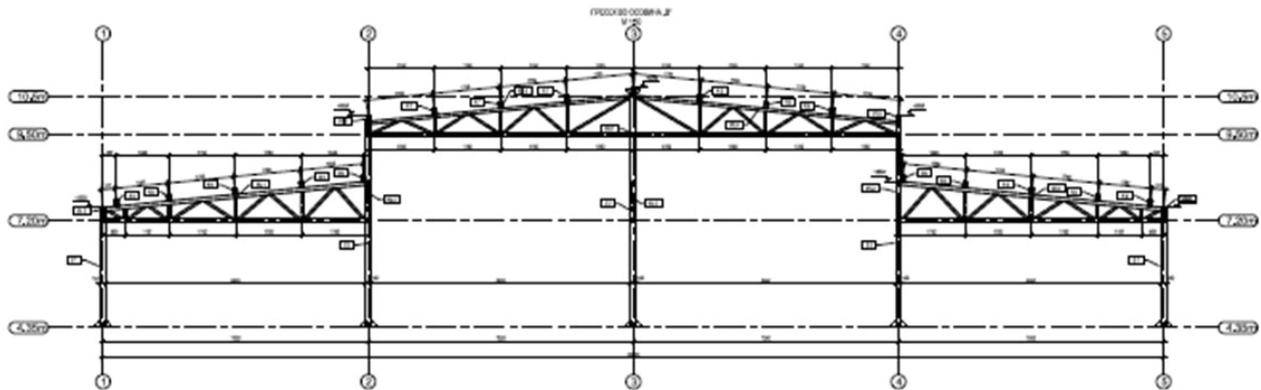
Figure 7. Section along B-axis

The truss girders at the lower part (RN1, RN2 and RN3) have been designed with flanges of SHS100.5 and diagonals and verticals of SHS60.4. The truss girders in the upper part in

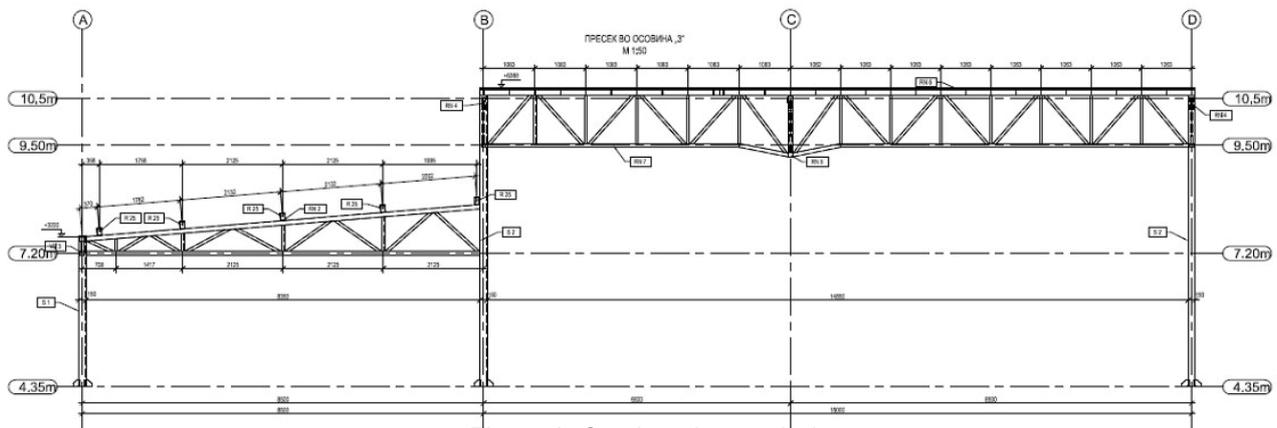
Figure 8. Section along axis 3

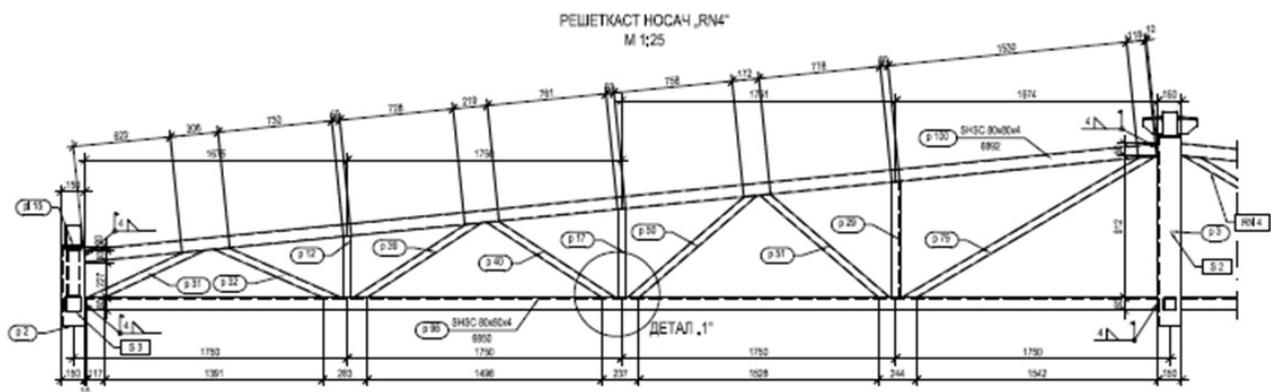
the rows B and D (RN4) have been designed with flanges of SHS80.4 and diagonals of SHS50.3, see Fig.9. The truss in the row C (lines 2 and 4), with a span of 14m has been designed with flanges of SHS100.5 and vertical and diagonal elements of SHS80.4 and SHS60.4. The connection along the lines 1 and 5 and row A, at the lower part, is realized with Vierendeel girders, as well as for the connection along the lines 2 and 4, at the upper part, see Figure 10.

Figure 9. Truss girder RN4

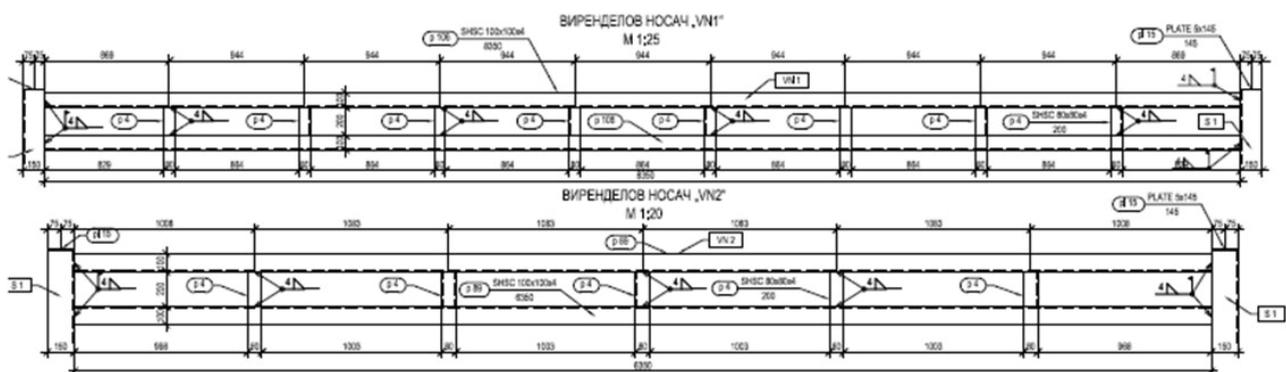
Figure 10. Vierendeel girders
