SOLVING PROBLEMS IN WOOD PARQUET PRODUCTION BY USING “7 STEPS” OF WORLD CLASS MANUFACTURING (WCM) METHODOLOGY

The paper presents the method for solving the problem in production by using “7 steps” of World Class Manufacturing Methodology (WCM). For each company with serial production, it is important to know what to “attack to achieve goals and to increase the OEE”. The goal of each company is to reduce financial losses but it is important to how to efficiently achieve that. In this case one of chronic problems in lacquering line goes to loss due to the splitting of sanding paper in the share of 27% of process loss, or 7% of all losses for that line. The way to solve this problem was by using “7 steps methodology”. Indicator for solving the problem was % of influence on Overall equipment effectiveness (OEE). A more detailed analysis shows that there are four possible causes of this problem. Type and quality of paper end connection had the biggest impact. The problem was solved by changing quality of paper and its connection. One very “easy” solution for unnoticed loss caused very big saving for the company.

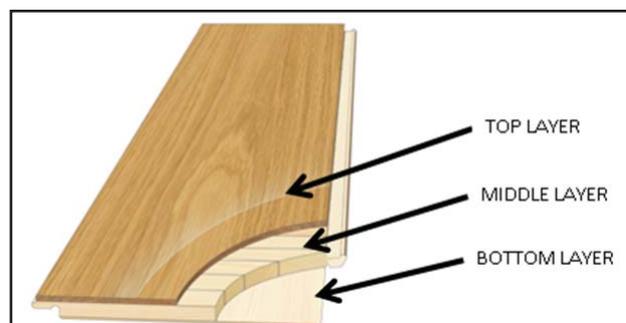
Figure 1: Three-Layer Parquet

Material is tree-layer parquet of 14.1 mm thickness, with top layer of 4 mm thickness, made of hard wood and composed of lamellas 66 mm wide with different lengths, middle layer transverse lined to top layer, made of wood slats of spruce species of 8.7 mm thickness, and bottom layer of spruce veneer of 2 mm thickness (Figure 1).

All the layers are glued under pressure at the temperature of 100 °C.

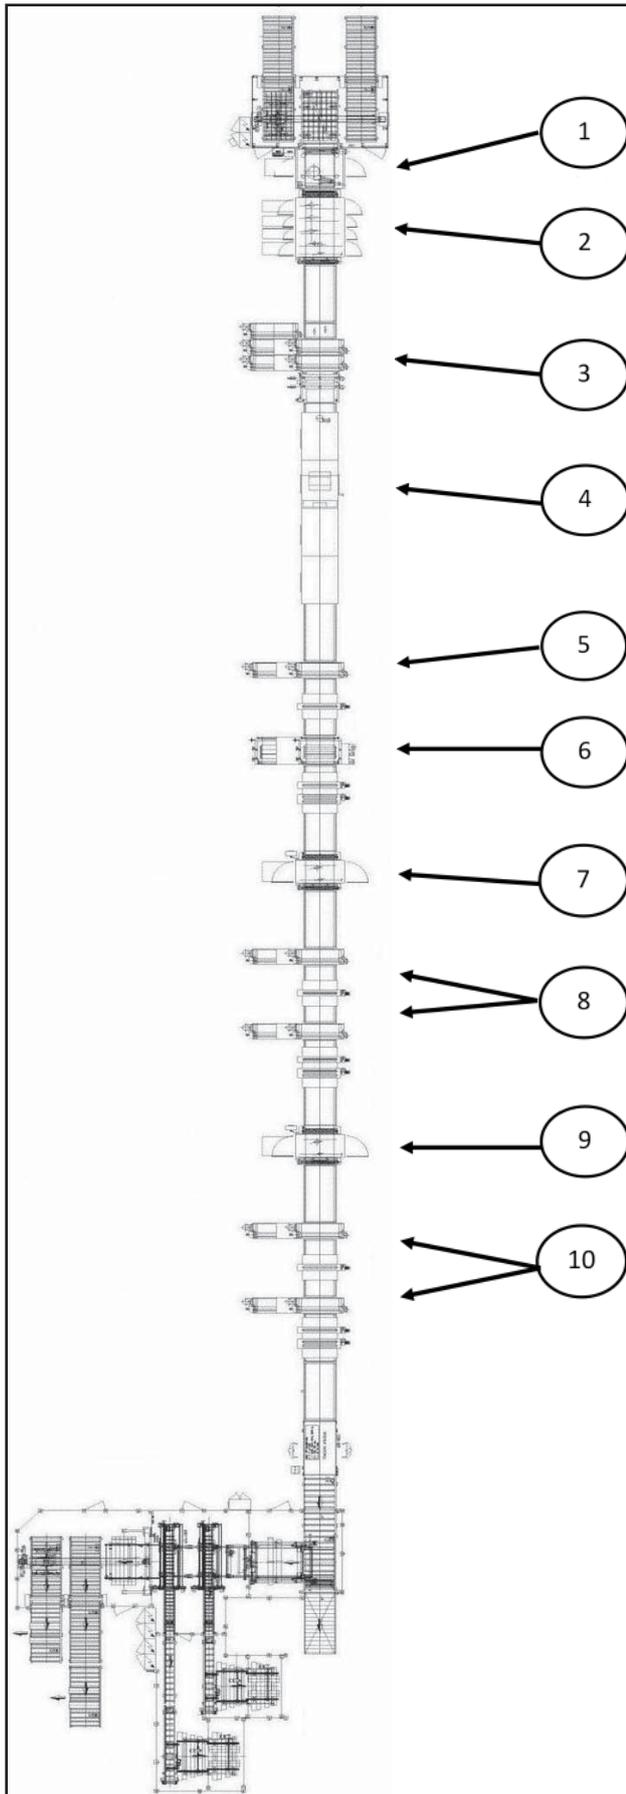
Figure 2: Schema of the lacquering line

Production of three-layer parquet consists of five production lines, namely line for making top layer, assemble line, lacquering line, profiling and packing line. Improvement in OEE had been done on lacquering line (see Figure 2).

The line starts with sanding machine (1) for sanding the bottom of parquet boards and makes the first base for further processing. It is followed by the sanding machine with four aggregates for processing wood layers from top of the boards (2). If products need to be coloured, they will be coloured on the machines for colouring (3) and dried in the chamber (4) and if not, the boards will just pass through them. Further, basic lacquer (5) and sealant (6) will be applied on the boards. After each lacquer application, boards go under UV lamps for curing.

Very thin layer of lacquer will be taken off under the third sanding machine (7) and in order to prepare the surface for applying two more layers (8) which will be cured under UV lamps too. Applied and cured lacquer will be finally sanded in the sanding machine number four (9). Boards will be lacquered two more times on the machines (10) and cured two more times under UV lamps. Lacquering line works in continuous mode and each breakdown will make the process stop in the part of line which precedes the part of line where the breakdown occurred. Capacity of the line is about 5.000 m² per shift. Process parameters are controlled every 15 minutes. The lacquering line is operated by two operators.

Collected data for unplanned changing of sanding paper, in the reference period of six months, indicate that the second sanding machine (item 2 in Figure 2), which has four sanding aggregates for sanding wood surface of parquet top layer (see Figure 6), out of four in the whole line, has the majority of breakdowns with 91%.

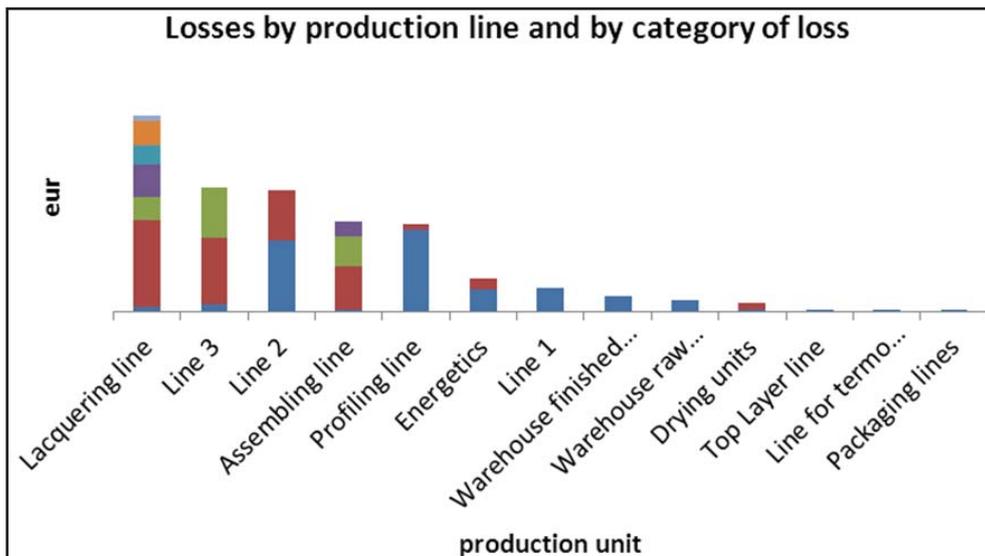
Figure 3: Structure of the losses on the line of three-layer parquet production

The biggest losses in parquet production are on the lacquering line (see Figure 3). This figure was obtained by analysing the collected failures data and the result is presented in monetary units.

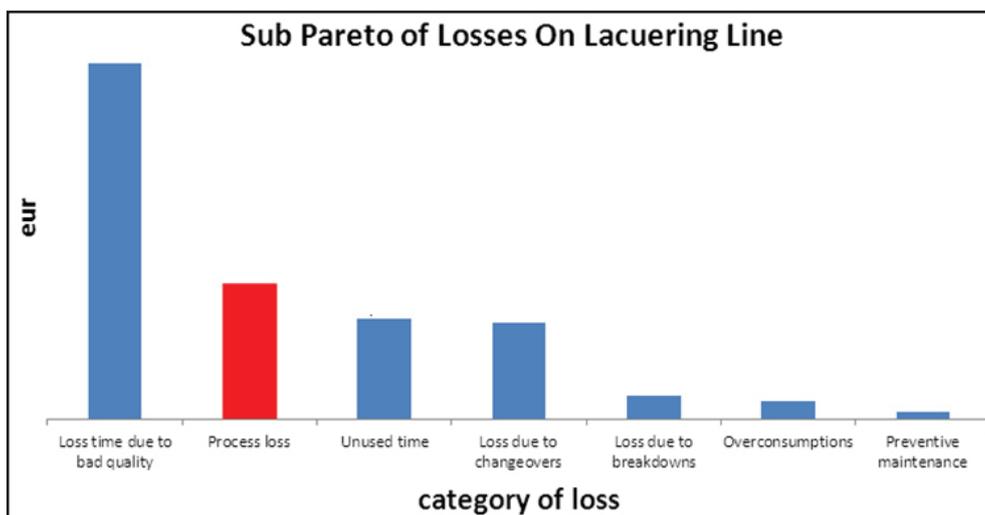
Figure 4: Losses on lacquering line by category of loss

With detailed analysis, measured in reference period for the lacquering line by using the techniques of Pareto and SubPareto analysis, which helps to identify the top portion of causes that need to be addressed to resolve the majority of problems, after loss due to bad quality, process breakdowns take the second place with share of almost 19%, (see Figure 4).

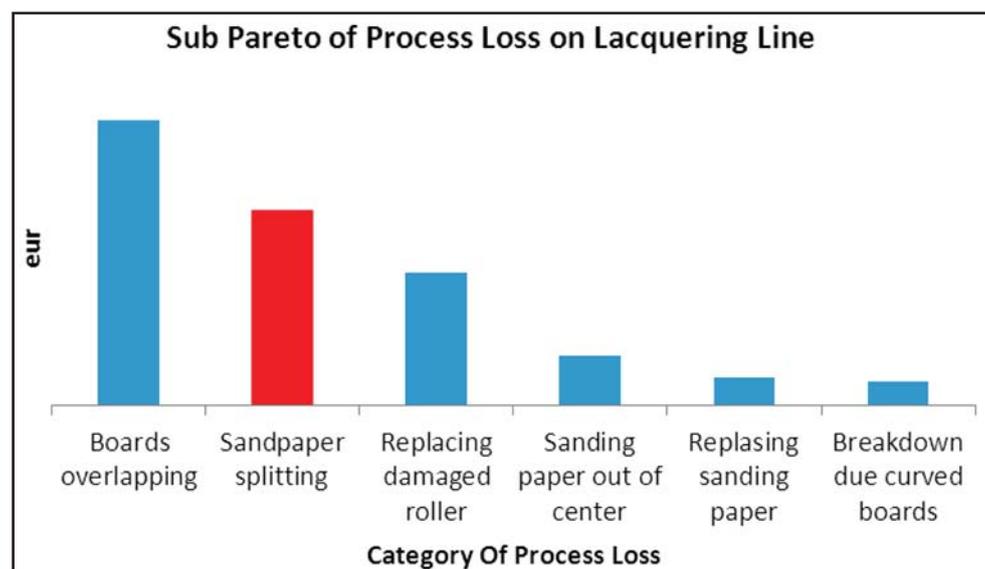
Figure 5: Process losses divided by categories

Among them, loss due to unplanned breakdown of sanding paper which occurred due to unknown cause takes the second place in share of process loss of 27%, or 7% of the total loss on lacquering line, (see Figure 5).

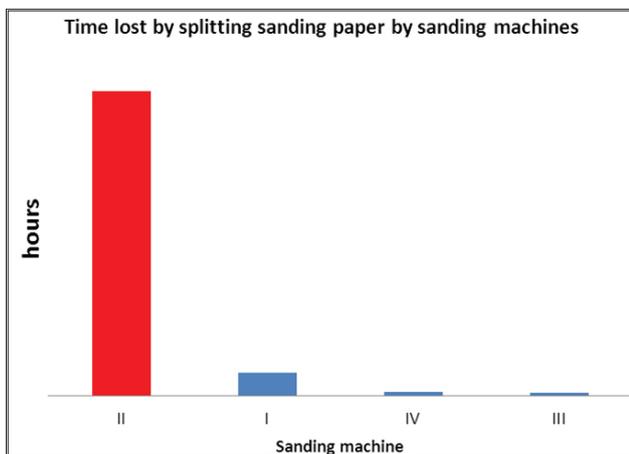
Figure 6: Pareto analysis by time lost due to breakdown caused by split sanding paper

Also, splitting mostly occurred on aggregate positions number one and two (see Figure 6).

Calculating in hours of breakdowns due to splitting of sanding paper, Figure 6 shows that machine on position two takes the largest part of all breakdowns. Analysing only the second machine, it is obtained that most of these breakdowns occur on the first and the second aggregate and consequently these two positions need to be resolved as a priority (see Figure 7).

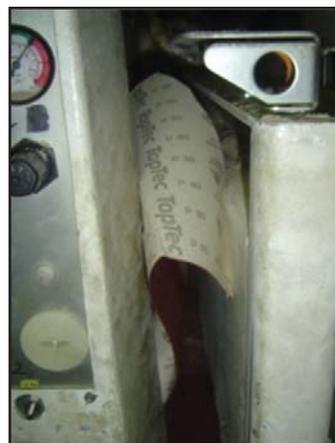
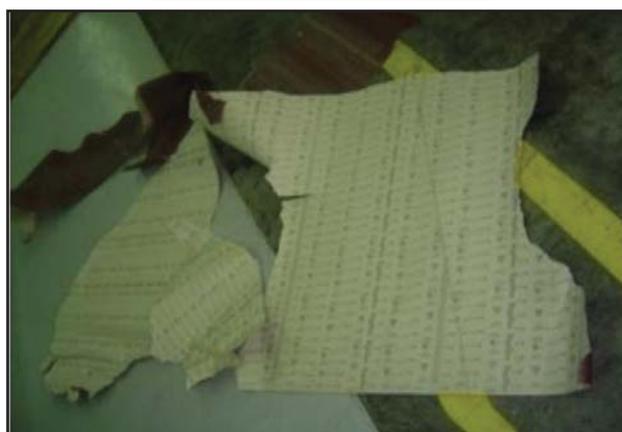
Figure 8: Examples of broken sanding papers

Collecting data – Trained operators were collecting data on the line. For every breakdown, operators were recording the cause of breakdown, type of sanding paper and time spent to solve the problem (see Figure 8). Due to high velocity of rotation of sanding paper and narrow working space in the machine, the sanding paper was split in a variety of sizes so it was very hard to define in which area the paper started to crack. Time to adjust technological parameters and restart production depends on the complexity of breakdown caused by the split sanding paper.

It may take more or less time depending on how many pieces of paper were left in machine after paper tearing. Almost every time during such breakdowns the material is beneath the sanding paper and this material goes to waste because there is no-material-flow, so the sanding paper makes deep defects on the surface of the material which is not moving.

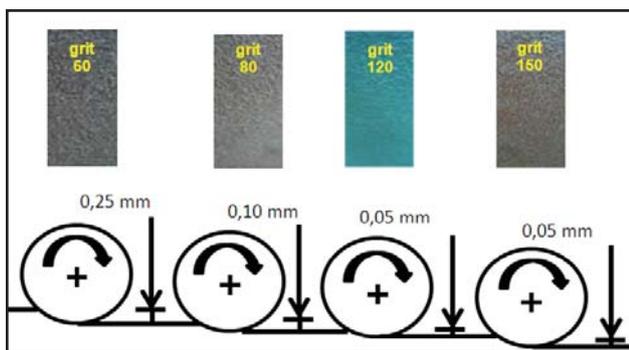
Figure 9: Schema of aggregates of the second sanding machine and amount of wood with characteristics of sanding papers

- The first hypothesis was that the amount of sanding for the first two aggregates was too high and that it needed to be decreased (see Figure 9).
- The second hypothesis was that the connection of the ends of the paper did not

The first system adjustment refers to adjusting the thickness of sanding on the first two aggregates, which was quickly done. New parameters were set up but the results remained the same, without any improvements.

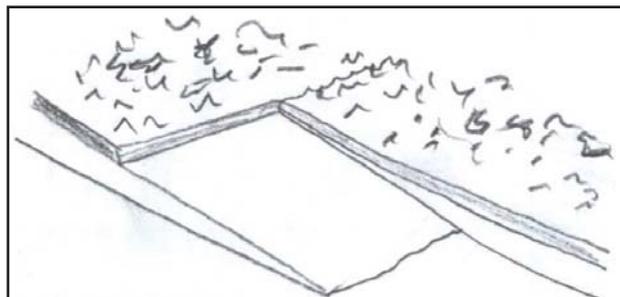
Figure 10: Schema of sanding paper joint connection

The second adjustment was to introduce a sanding paper jointed in a new way, textile-based and with thin foil on the backside to reinforce the connection, as recommended by the supplier. After the implementation of this measure, the number

of breakdowns significantly decreased. Based on the obtained results of the implemented countermeasure, getting a new tension roller was unnecessary at first glance but it was a good indicator that one more activity, namely checks of roller wear, needs to be incorporated in the monthly maintenance plan. No further modifications were made on the sanding machines on the positions three and four since 91% of breakdowns occurred on the first two machines.

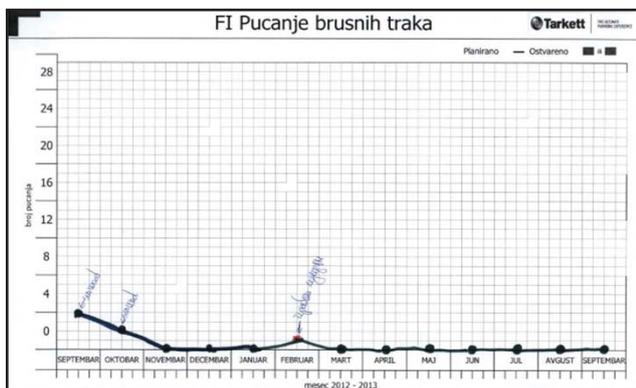
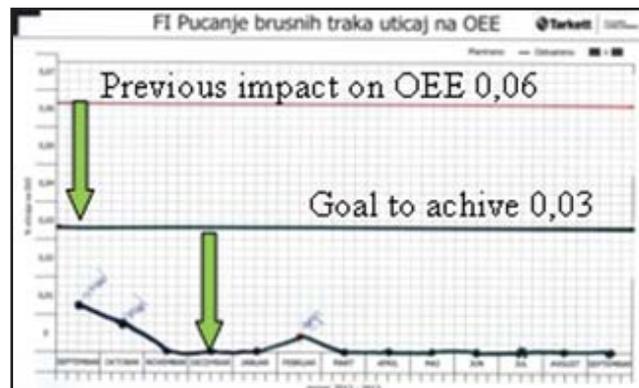
Figure 11. Checking chart a) Chart for tracking number of breakdowns due to split sanding paper; b) Chart for tracking influence on OEE due to breakdown caused by splitting of sanding paper

Since the paper splitting did not appear every day, we could not connect the obtained results with the countermeasure applied at that time. The countermeasure to change paper base from paper to textile and the way to link end-connections from overlap to ultra-thin foil on backside gave us good results. Figure 11 presents results for the second sanding machine, the first and the second aggregate, with achieved results for zero breakdown on model area for specific KPI due to splitting of the sanding paper and the influence on OEE, as a global KPI, to reduce from 0.66% to 0.33% (in total, the influence on OEE was eliminated 100%).

Achieved results were better than the planned since the goal of 0.03% of impact was overcome and now it is 0%. Certain deviations of the goal, see Figure 11, are due to mechanical problems and use of sanding paper from another supplier. Loss in unused working time and unnecessary use of new sanding papers in the amount of tens of thousands of euros on annual level was decreased. Countermeasures eliminated unplanned replacement of sanding paper, engagement of operators for not standard operations and loss of available time.
