TESTING THE CHARACTERISTICS OF FREE AND FORCED OSCILLATIONS ON FAP 2228 OFF-ROAD VEHICLE

The paper presents the testing of free and forced oscillations characteristics on FAP 2228 BS/A-45 off-road vehicle. The testing of free oscillations was conducted according to SORS 9127 (Standard of Defence of the Republic of Serbia) in laboratory conditions. The testing of forced oscillations was conducted in the course of driving on various surface paths - the heath in Deliblatska pescara, gravel at the territory of Fruska gora, on concrete surface at the runway of the Kovin airport, as well as on the asphalt surface of Belgrade-Šid highway. The testing was carried out according to SORS 0318 and ISO 2631 standards, and the results were evaluated according to 2002/44/EC Directive.

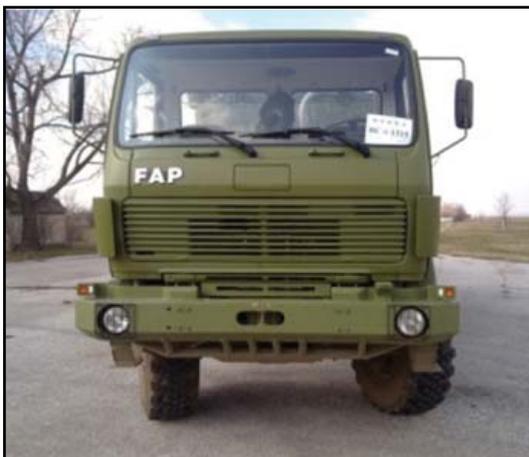
Figure 1: FAP 2228 BS/A-45

As these vehicles are not used only during war, but also in peace time, it is necessary to establish the standards which must be applied in order to protect the health of their users. A special problem related to military vehicles results from the fact that they are very durable and last long, and therefore they do not fulfil the standards which the automobile industry started applying in the last ten years [05, 07]. Also, due to the special requirements set before the manufacturers regarding dynamic passability, the autonomous movement, the reliability of fitted components, as well as the accommodation of special equipment and weaponry, the price of manufacturing such vehicles is very high. It is a frequent case in practice that during the designing of superstructures to be installed on a basic type of a vehicle the constructors are faced with huge problems how to reduce the level of vibrations and noise inside the cabin to an acceptable level required for uninterrupted operation of the carrier [06, 08]. The main and transversal supports are connected by screws and rivets. The platform is equipped with JOST locks for container connecting. Overall dimensions of the vehicle are (length x width x height) 9,615 x 2,500 x 3,180 mm.

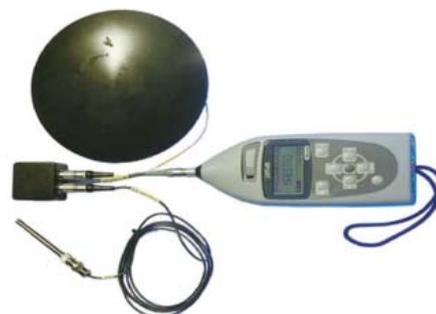
Figure 2: Maestro

Portable MAESTRO human vibration meter, manufactured by 01dB-Metravib, was used to measure the vibrations on the seats of both the driver and passengers in the vehicle cabin and the superstructure. This meter is intended primarily for human vibration measuring, i.e. measuring and calculating the influence on the human body (measurement of vibrations at the workplace which are transferred to the whole body or to the hands).

Alternatively, it is used to measure the level of noise (as four-channel system, the first three channels are intended for three-axis accelerometers, and the fourth channel can be connected to the one-axis accelerometer or to a preamplifier with a microphone; it is adapted for measuring the efficiency of the seat and as a basic vibration meter).

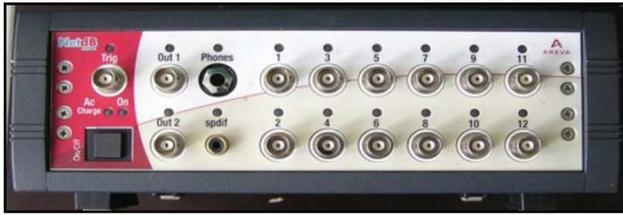
Figure 3: NetdB12

Its integration time ranges between 1 and 200 seconds and it has the possibility of start/stop mode, the memory capacity is 2 MB, as well as analogue output: 4-pin LEMO connector for signal recording or monitoring of all four channels within the range from 0.4 to 1000 Hz. The autonomous operation (when not plugged in mode) depends on the battery life and on an average it is from 8 to 13 hours. Free oscillations were measured by NetdB12 (01dB Metravib) vibroacoustic measuring system manufactured by Areva, as well as NF piezoelectric accelerometers (type STS AS135/1A).
